INSPECTION AND ANALYSIS  
FOR THE  
ROMAR TOWER  
CONDOMINIUM

Orange Beach, Alabama

Prepared By:  
Cornerstone Facilities Engineering, Inc.  
January 2008

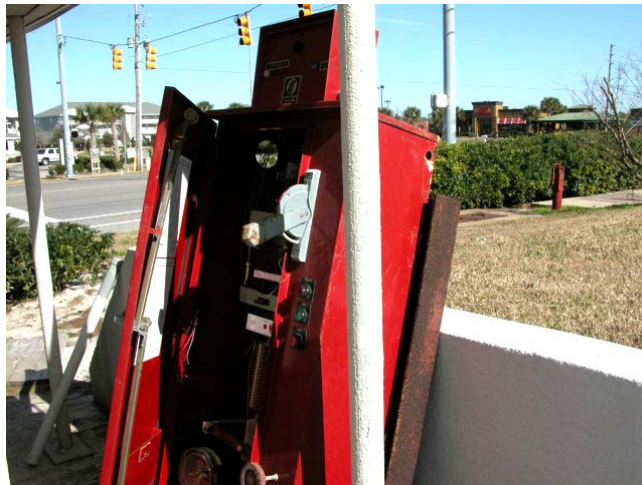
Old fire pump controller.

These items constitute a safety hazard especially for children who may get cut and/or crushed in attempting to play with these large metal objects. They should be removed as soon as possible.

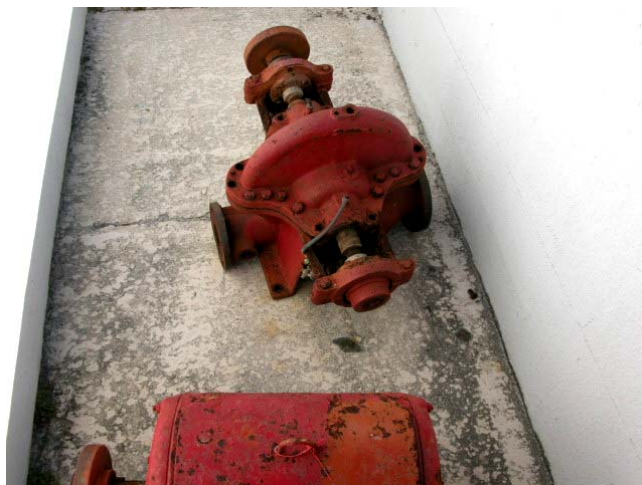
Old fire pump and motor.

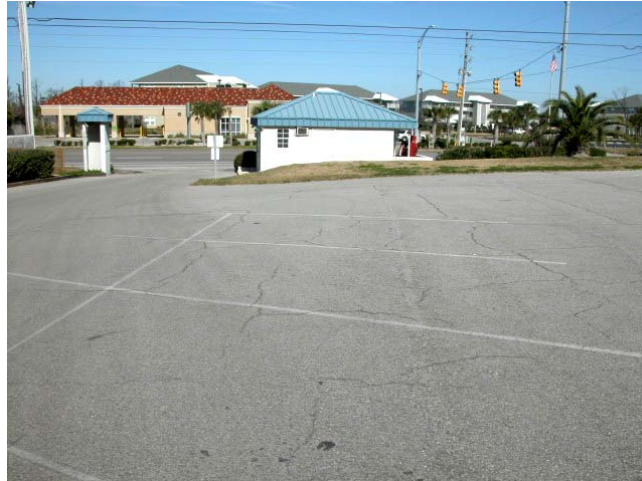
2. **Paving** – The current drives and parking paving in general are in good to fair condition. The spreadsheet provides for funding of a project in the future to upgrade asphalt paving conditions and to correct minor, distressed areas and to reseal the asphalt to protect it from oils and water intrusion and eventually provide for an overlay of the asphalt. The slopes and breaks in the paving appear to be adequate for moving stormwater away from pedestrian ways.

Asphalt paving in parking area.

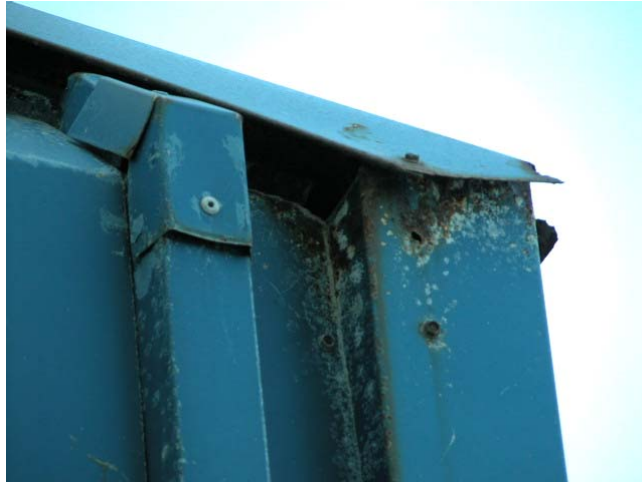
Metal Roofing at Entry: The metal roofing here is not in as good of a condition as the main roof. The photographs below show some of the distress.

Corrosion damage at roof corner.

It is suggested a fund be started to fund the replacement of the roofing. Based on the size of the roof this project will likely cost \$23,000. The current roof can be expected to last approximately another five years. The funding shown provides for the cost of this future project.

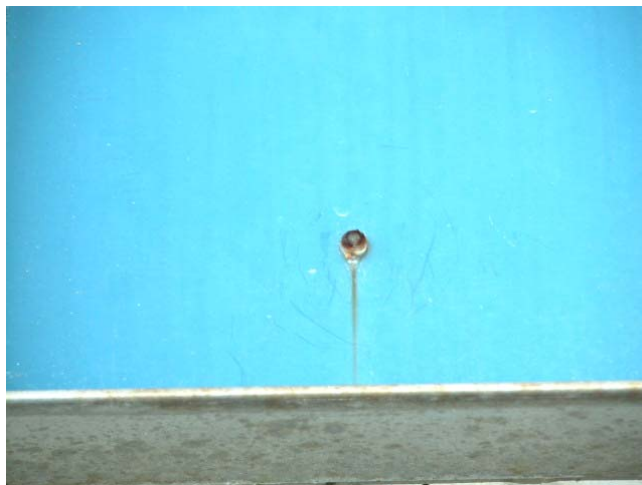
Corrosion of fastener that holds metal panel in-place.

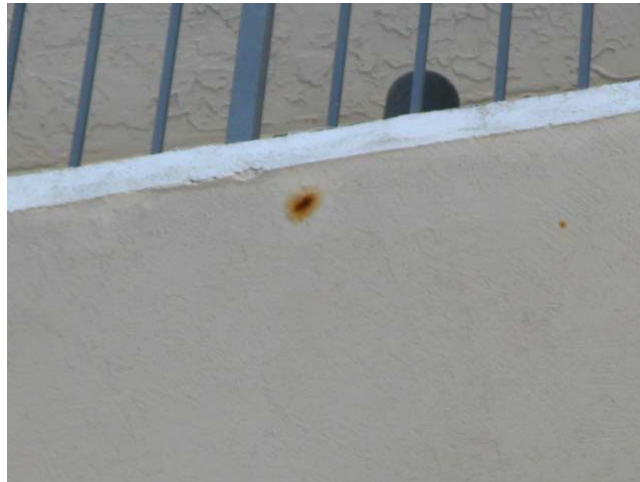
- 6. Walks, Balcony and Upper Walkway Concrete** – The concrete for the balconies and walkways are in good structural condition. There are signs that the reinforcement has been impacted by water intrusion over the years. Water

intrusion carries sodium chloride (salt) into the concrete and this in turn corrodes the reinforcing bars (rebar) that are in the concrete. The photograph below shows one area where this has occurred.

**Rust spot forming on the concrete of a balcony.**

The cost to correct those items has been estimated and shown on the spreadsheet. It is suggested the work be done in conjunction with the 2013 exterior coating and waterproofing project.

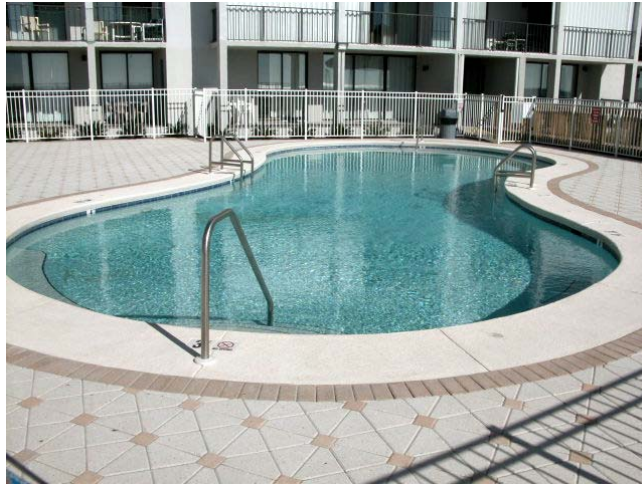
- 10. Pool and Spa Area and Equipment** - The pool was recently installed and is in very good condition. All mechanical systems are of first quality and should be capable of being maintained with normal maintenance. The budget shown should accumulate funds for upkeep of the pool and its related equipment. This fund will also be the source for refinishing the interior of the pool which will be required about every 10 years.

Pool and deck area.

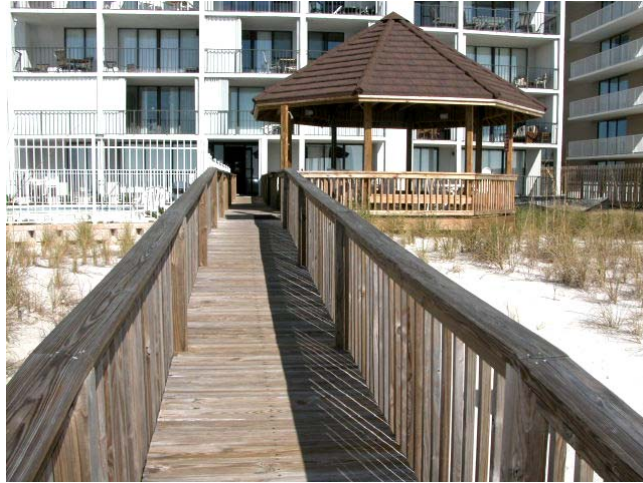
**Beach Access & Gazebo**

**12. Beach Access Structure & Gazebo** – The beach access structure is in good condition and has no current problems. A fund for regular repair of the structure should be considered to keep the walk in good repair and safe for use. Also this fund is to be used for maintenance of the gazebo.
