INSPECTION AND ANALYSIS FOR THE ROMAR TOWER CONDOMINIUM

Orange Beach, Alabama

Prepared By:
Cornerstone Facilities Engineering, Inc.
January 2018

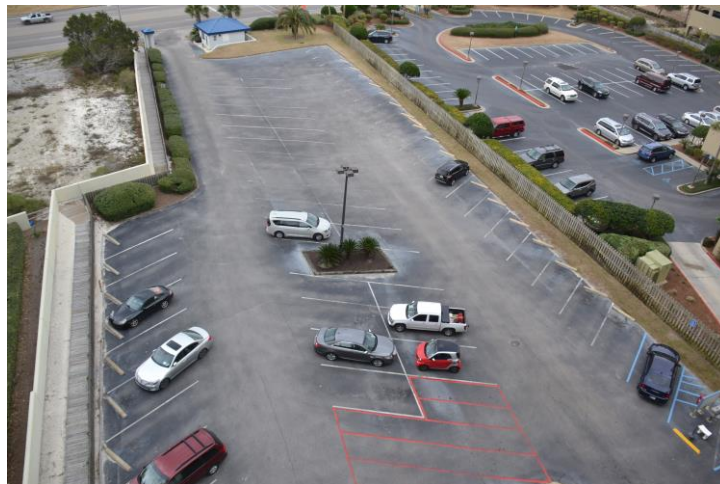
2. **Paving** – The current drives and parking paving in general are in good to fair condition. The spreadsheet provides for funding of a project in the future to upgrade asphalt paving conditions and to correct minor, distressed areas and to reseal the asphalt to protect it from oils and water intrusion and eventually provide for an overlay of the asphalt. The slopes and breaks in the paving appear to be adequate for moving stormwater away from pedestrian ways. The funding provides for an overall overlay project of \$80,000 in expected cost to be needed in approximately 20 years.

Asphalt paving in parking area.

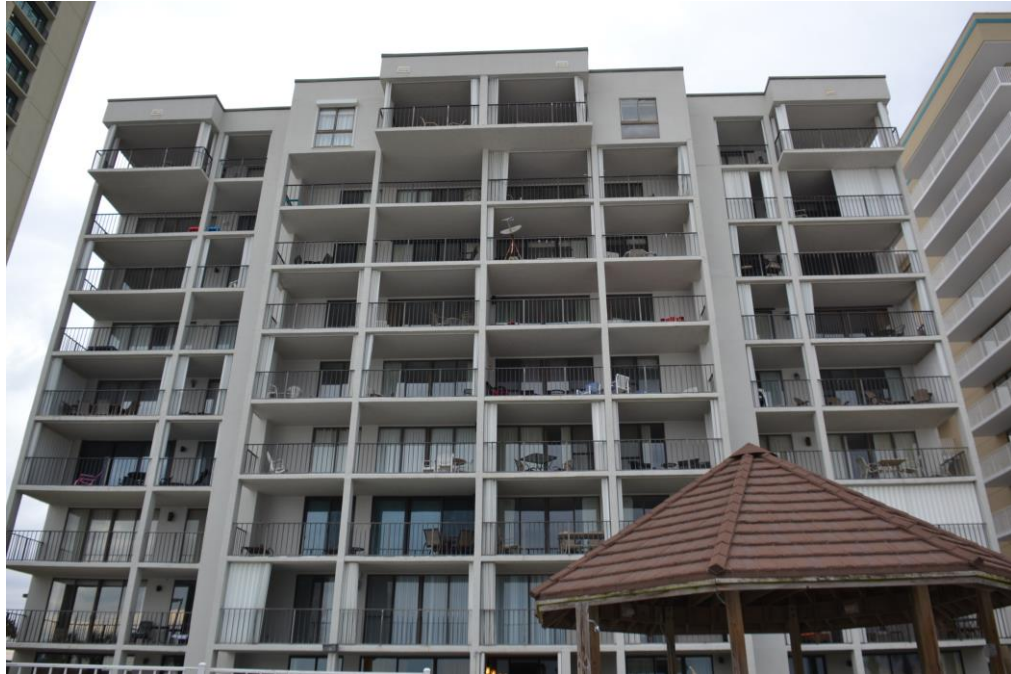
3. **Exterior Sealing & Painting** – The exterior of the Romar Tower Condominium is all stucco application over concrete and sheathing. The system on the building's exterior walls and other surfaces are in relatively good condition. The building was last recoated in approximately 2015 with

elastomeric products. The coatings have held up very well but will need to be refreshed in a few years in order to continue to provide adequate weather protection for the structure.

South elevation of building

It is suggested that recaulking and coating (painting) the building be planned for the year 2022. The spreadsheet is based on the year 2022 project plan and a total project budget of \$132,500. After that project, the building's exterior should be resealed every seven to ten years. This type of program will also result in providing an attractive appearance that is an important part in maintaining the value of the property.

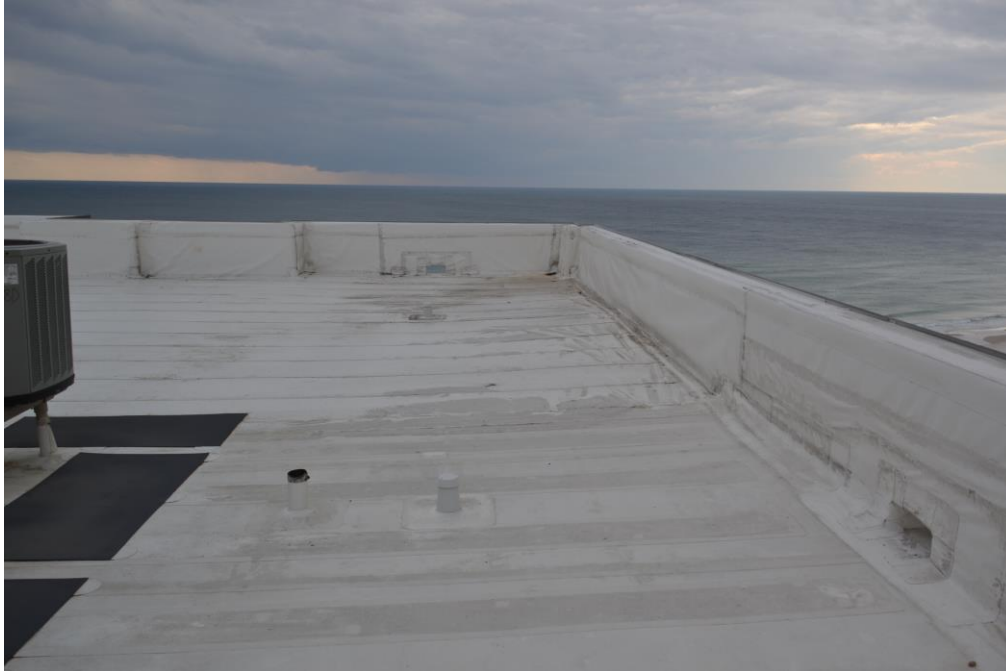
4. **Roofing** – Main Roof: The single-ply, PVC roofing is in good condition. It was installed in 2005. It is our estimate, that the existing roof will provide 10 to 15 years of service before the system requires attention. The allocation of reserve funds to the roofing account has been based on beginning to accumulate funds for the roof repairs when they become necessary. The parapet details of the buildings, as well as the through roof details, appear to be of good quality and correctly installed. The suggested reserves will allow for accumulation of funds to address roof replacement when it becomes needed.

The single-ply roof has performed well and is in good general condition.

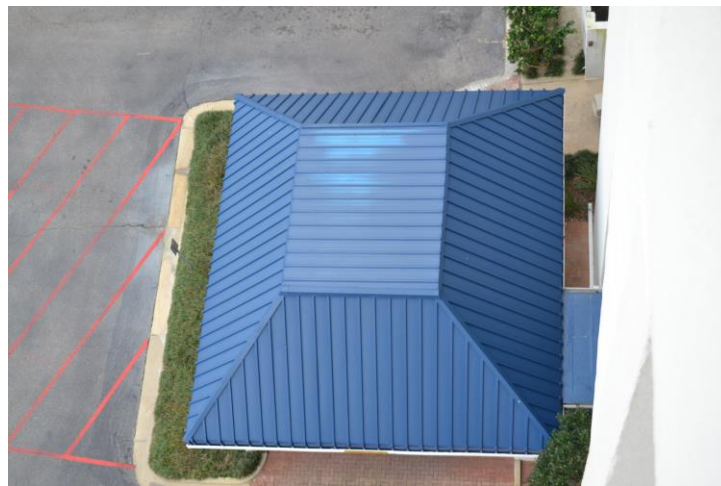
Metal Roofing at Entry: The metal roofing here is in good condition also. The photograph below shows the general condition.

Metal roofing at main entry.

It is suggested a fund be started to fund the replacement of the roofing. Based on the size of the roof this project will likely cost \$44,000. The current

roof can be expected to last approximately another 20 years. The funding shown provides for the cost of this future project.

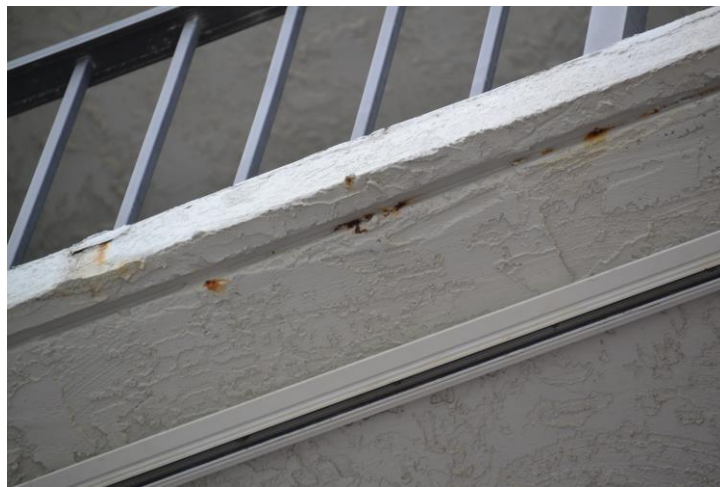
- 5. Walks, Balcony and Upper Walkway Concrete** – The concrete for the balconies and walkways are in good structural condition. There are signs that the reinforcement has been impacted by water intrusion over the years. Water intrusion carries sodium chloride (salt) into the concrete and this in turn corrodes the reinforcing bars (rebar) that are in the concrete. The photograph below shows one area where this has occurred.

Rust spots forming on the concrete of a balcony.

The cost to correct those items has been estimated and shown on the spreadsheet. It is suggested the work be done in conjunction with the 2022 exterior coating and waterproofing project. It is also suggested a separate fund to address future issues be kept for this activity because as the building ages it is probable more such damage may occur.

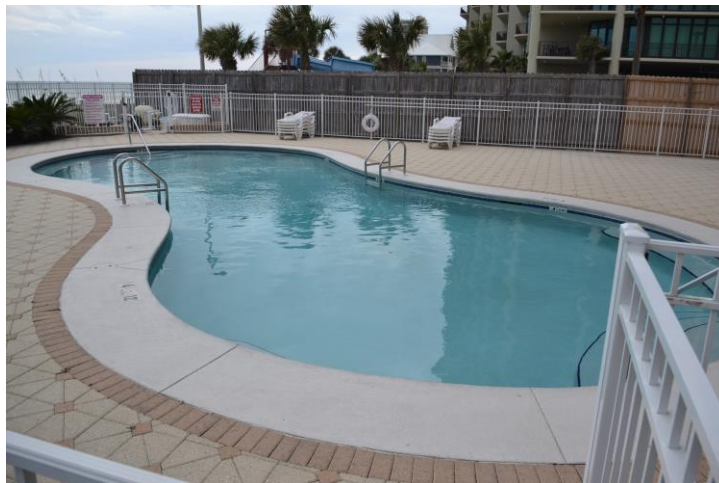
9. **Pool and Equipment** - The pool was recently installed and is in very good condition. All mechanical systems are of first quality and should be capable of being maintained with normal maintenance. The budget shown should accumulate funds for upkeep of the pool and its related equipment. This fund will also be the source for refinishing the interior of the pool which will be required about every 10 years.

Pool and deck area.

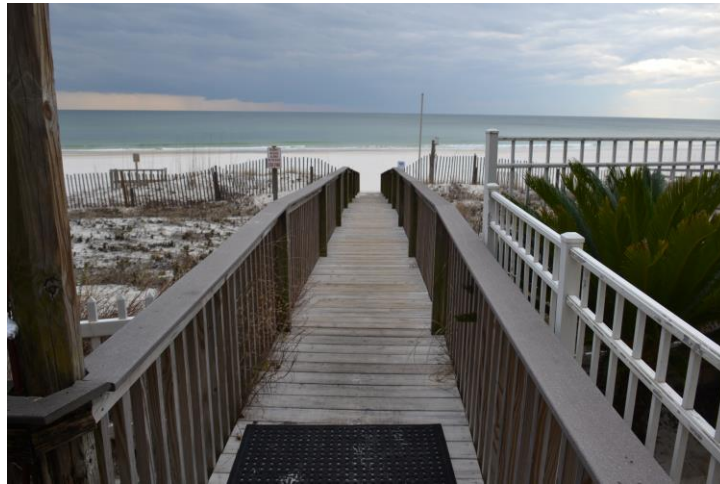
11. Beach Access Structure & Gazebo – The beach access structure is in good condition and has no current problems. A fund for regular repair of the structure should be considered to keep the walk in good repair and safe for use. Also, this fund is to be used for maintenance of the gazebo.

Beach Access

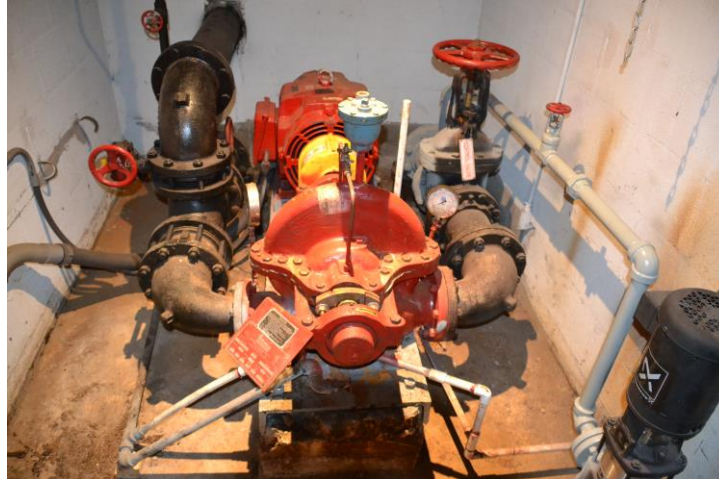
12. Emergency Systems – The standpipes, fire alarm, and emergency electrical systems were found to be in generally good condition. The funds shown are to provide regular, preventive maintenance and to accrue funds for the eventual replacement of the fire alarm system, maintenance to the fire sprinkler controls and replacement of emergency light fixtures.

Fire pump and its accessories were found to be in good condition
